TEST REPORT

SLIP RESISTANCE CLASSIFICATION OF
NEW PEDESTRIAN SURFACE MATERIALS

Woodland Lifestyle

Native Vinyl Plank, Brown, Vinyl Plank

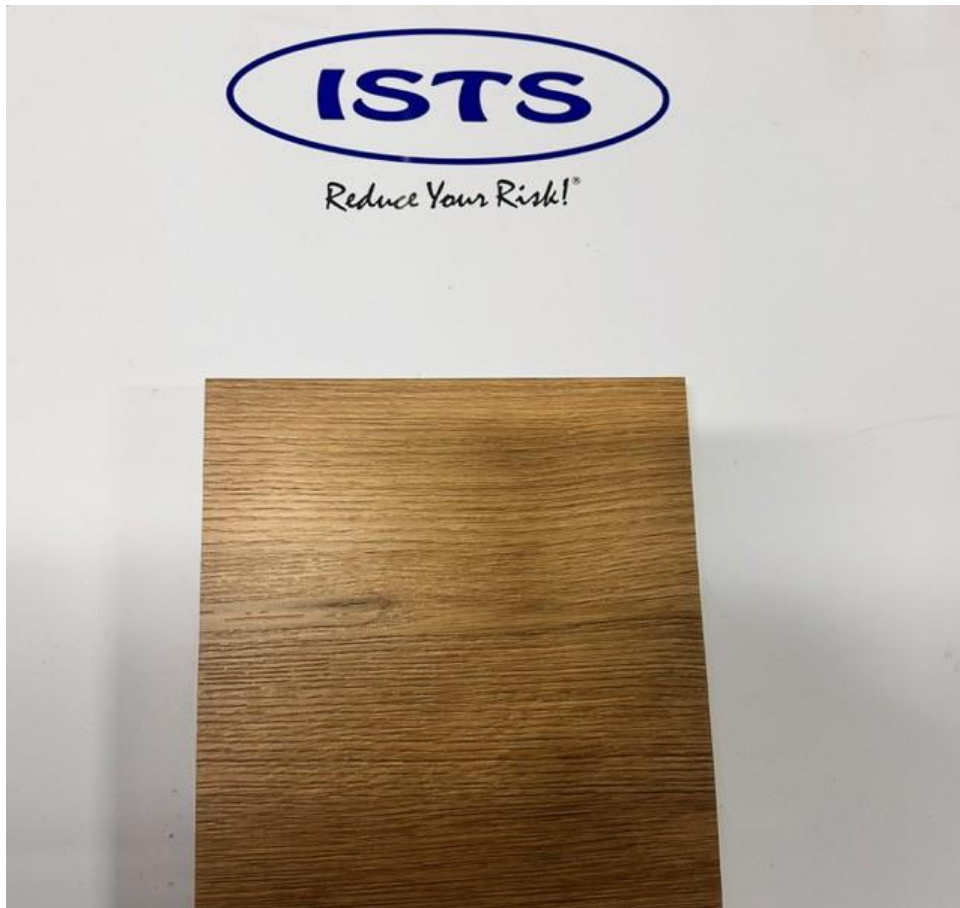
TEST PRODUCT IMAGE

Product Description: Nativer Vinyl Plank, Brown, Vinyl Plank

Test Date: 02-12-2024
